REPORT OF INVESTIGATION

Powered Haulage Accident
November 4, 2006

Mine #23
McCoy Elkhorn Coal Corp.
Pikeville, Pike County, Kentucky
ID No. 15-18721

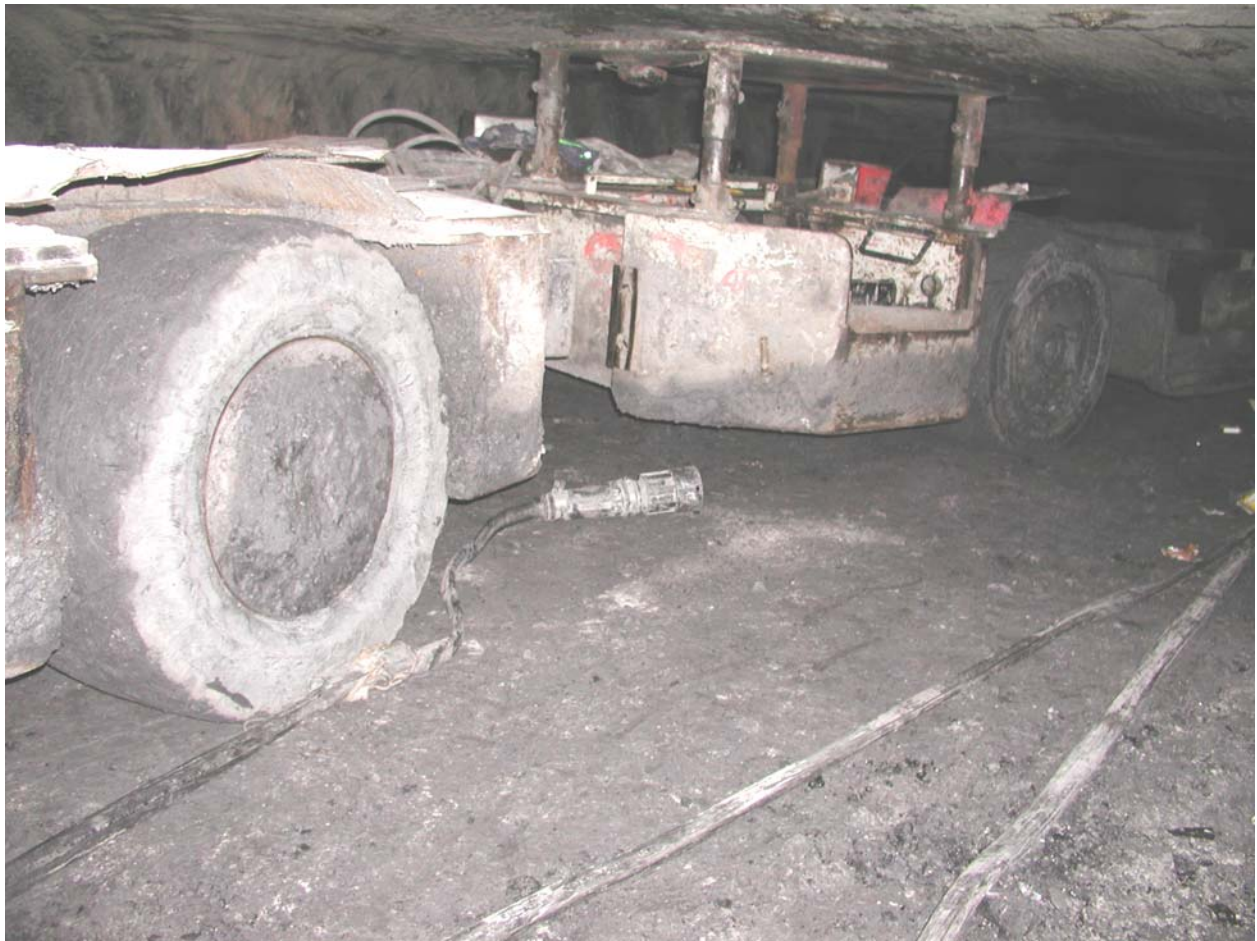
Photograph of Re-created Accident Scene

Swiney was using a battery powered scoop to pull a shuttle car cable toward the power center. The plug end of the cable had been wrapped around the canopy post of the scoop to facilitate pulling. The scoop ran over the cable, which became lodged between the scoop tire and the mine floor. The end of the cable unwound from the canopy post and the plug struck the victim in the head resulting in fatal injuries. The accident occurred because mine management, aware that cables were being pulled unsafely, failed to ensure that safe procedures for pulling cables with mobile equipment were established and followed.

The shuttle car trailing cable was a No. 6 AWG cable and was attached to the scoop by winding the plug end around the canopy post located on the outside corner of the canopy adjacent to the batteries (Reportedly this is a common practice to quickly attach cables for pulling.) Grab hooks were welded to each end of the scoop to facilitate attachment of cables with ropes. According to Mark Smith, shuttle car operator, a wooden block was often placed behind the ram of the scoop so the cable could be looped around the block to pull the cable from one location to another.

Corrective Action: The mine operator developed a policy for pulling cables with mobile equipment which specifies that ropes or straps designed for that purpose will be used and prohibits attaching the ropes or straps to the decks or canopies of equipment. All persons working at this mine were given additional training covering the cable pulling policy.

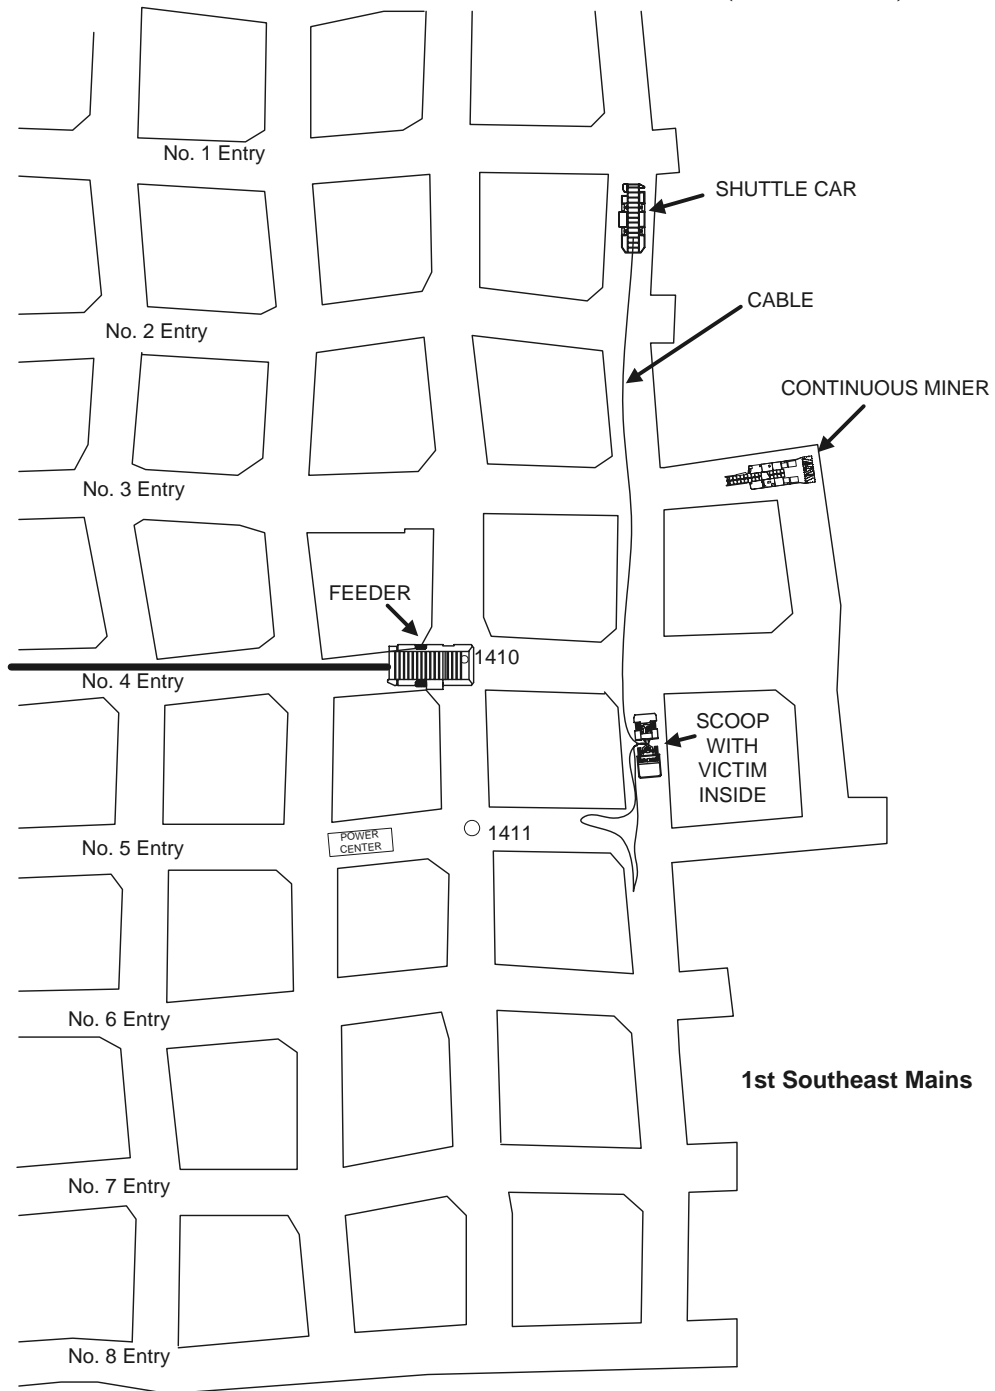
Appendix C
Section Sketch of Accident Scene - Plan View (Not to Scale)

Swiney trammed the scoop across the 1st Southeast Main section from No. 3 entry to the No. 8 entry pulling the shuttle car cable behind him. Stiltner walked behind the scoop until he reached the No. 6 entry where he waited to pull the cable by hand down the entry to the power center. Swiney reversed the scoop and pulled the cable from the No. 8 entry back to the No. 4 entry leaving the additional cable along the mine floor. Stiltner pulled some of the cable down the No. 6 entry and waited for Swiney to bring the cable plug to him. Swiney stopped at the No. 4 entry and reversed direction again and pulled the cable toward the No. 6 entry.
